Residential Subdivision
The Gardens - Stage 8
Site Classification

Medowie Road,
Medowie

NEW19P-0143D-AA
26 October 2021

**RE: RESIDENTIAL SUBDIVISION – THE GARDENS – STAGE 8
688 TO 730 MEDOWIE ROAD, MEDOWIE
SITE CLASSIFICATION (LOTS 801 TO 822)**

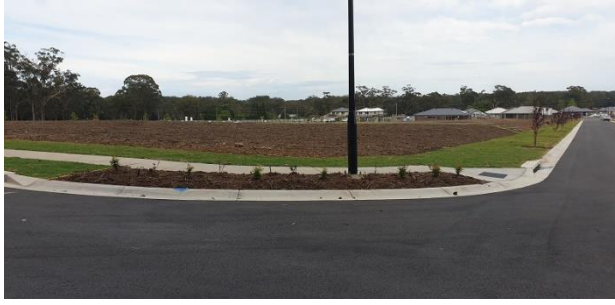
Photograph 1: From the intersection of Macadamia Circuit and Kingaroy Street, facing southeast.

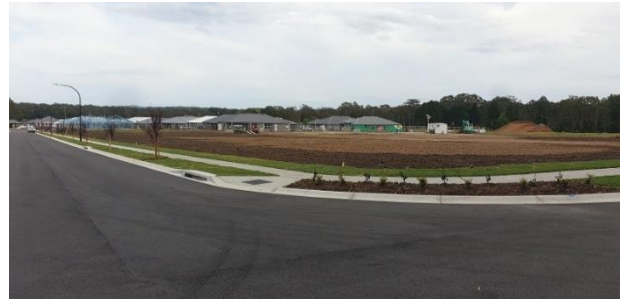
Photograph 2: From the intersection of Macadamia Circuit and Kingaroy Street, facing northeast.

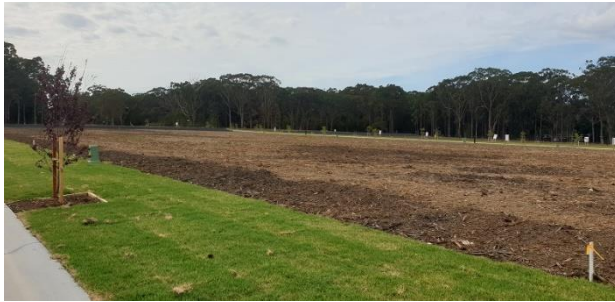
Photograph 3: From near north-eastern corner of Lot 801, facing southwest.

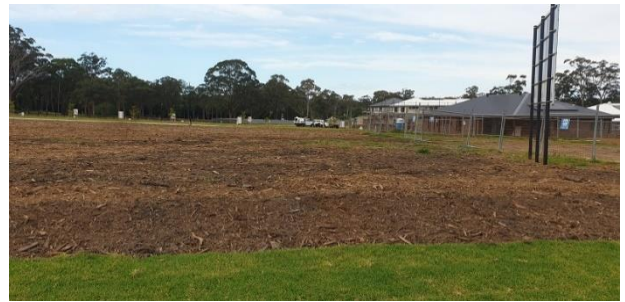
Photograph 4: From near north-eastern corner of Lot 801, facing south.

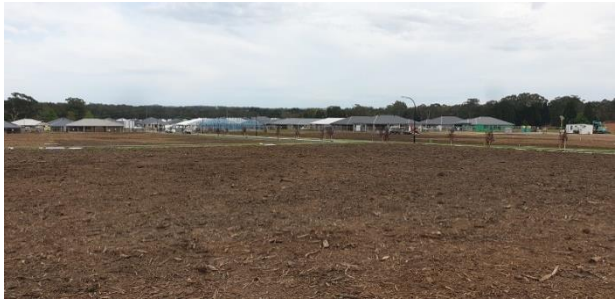
Photograph 5: From near southeast corner of Lot 810 facing northwest.

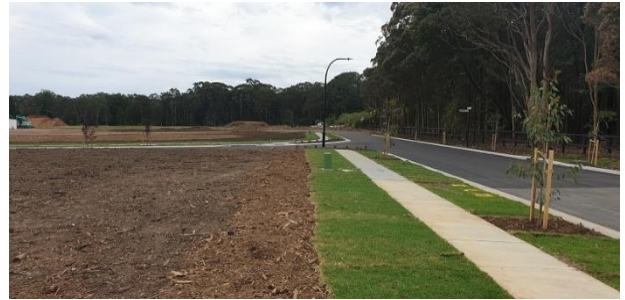
Photograph 6: From near southeast corner of Lot 810 facing north.

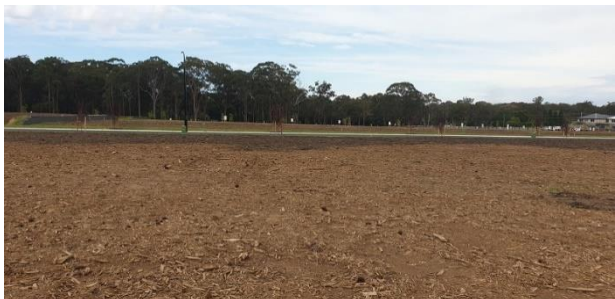
Photograph 7: From near north-eastern corner of Lot 813, facing south.

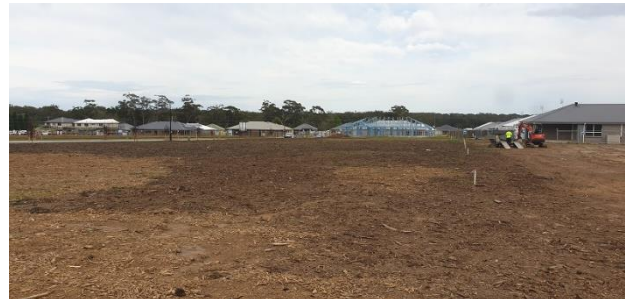
Photograph 8: From near north-eastern corner of Lot 813, facing west.

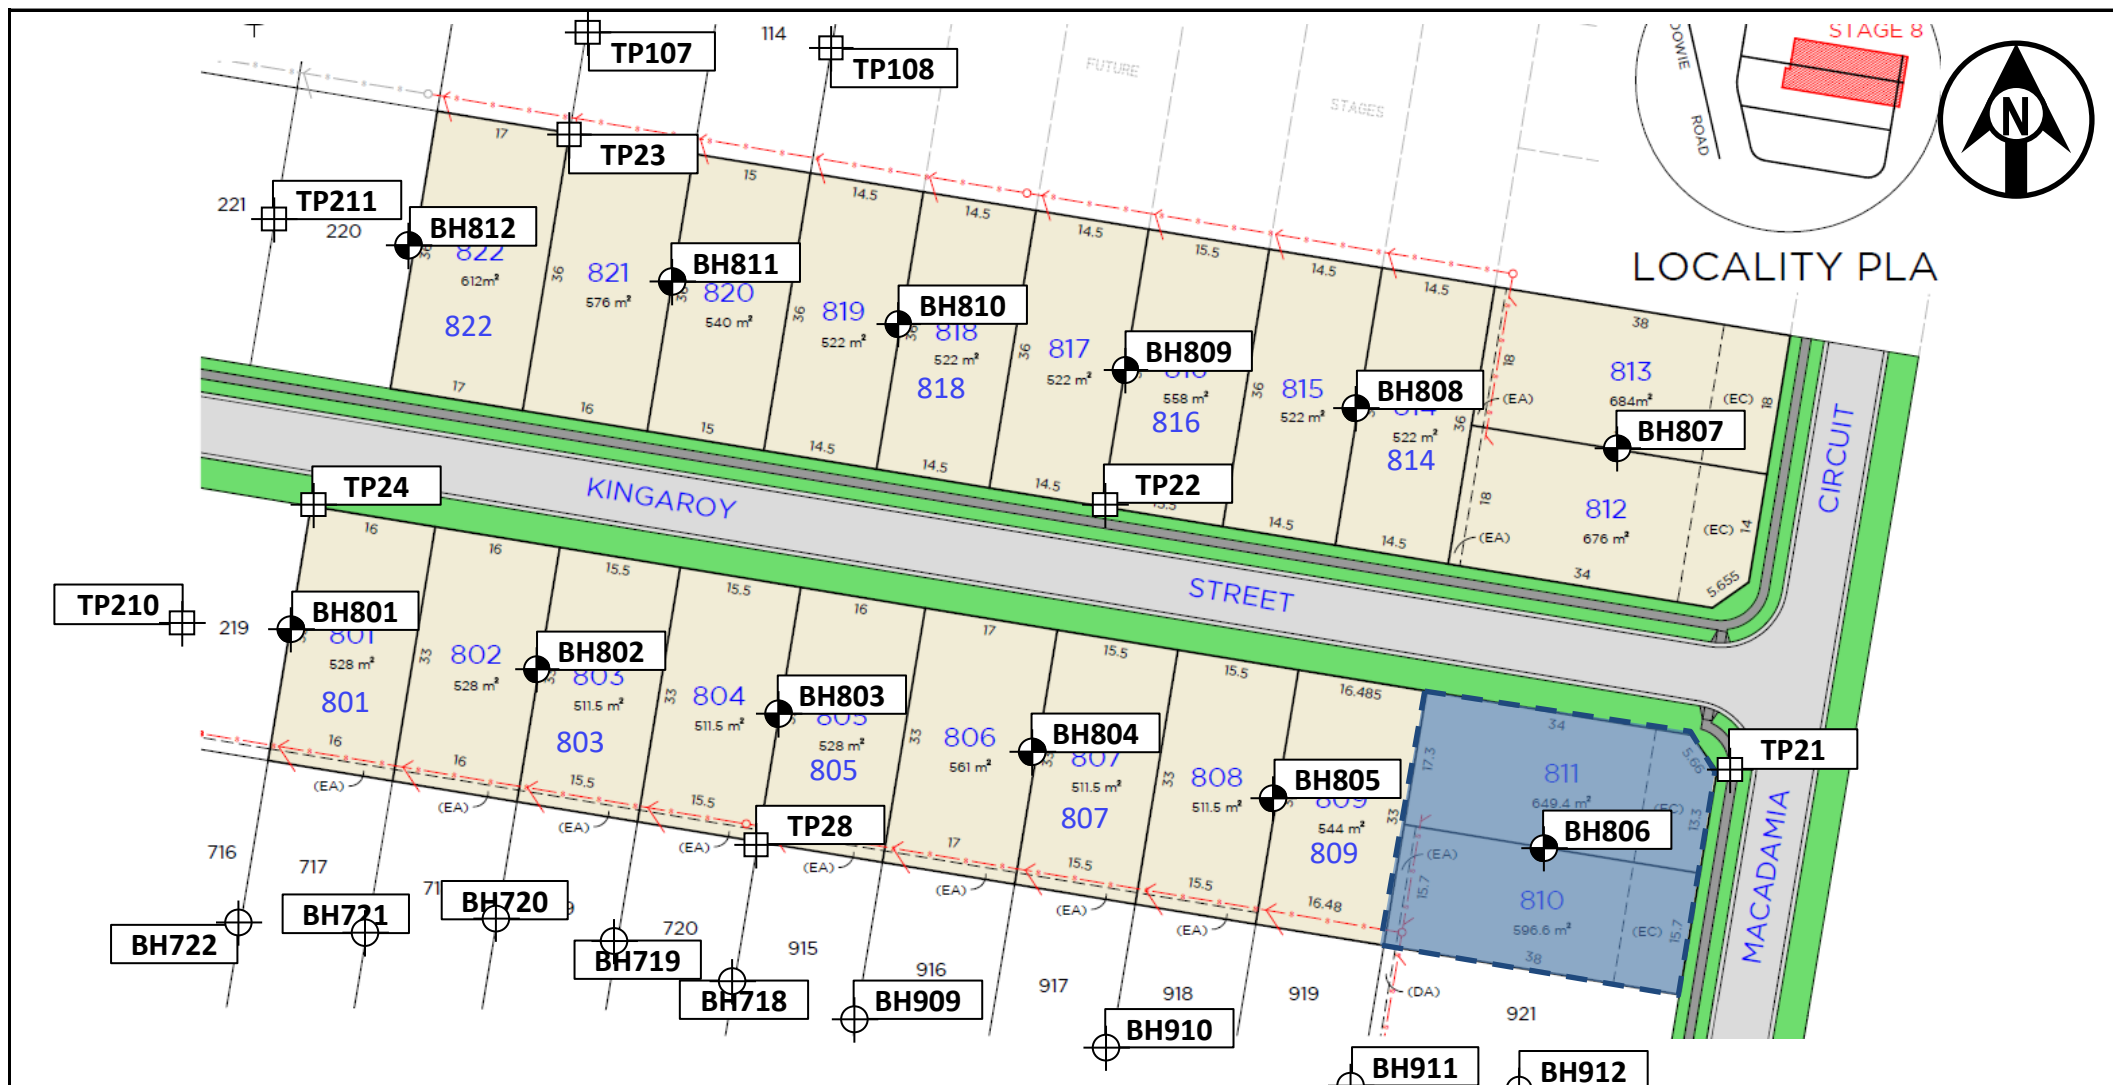
FIGURE AA1:

As the geotechnical testing authority engaged for the project, Qualtest state that the filling performed for the re-grade areas within Stage 8 (as noted above and shown approximately on Figure AA1) was carried out to Level 1 criteria as defined in Clause 8.2 – Section 8 of AS3798-2007, *"Guidelines on Earthworks for Commercial and Residential Developments"*.

Based on the results of the field work and laboratory testing, residential lots located within Stage 8 of The Gardens residential subdivision located at 688 to 730 Medowie Road, Medowie, as shown on Figure AA1, are classified in their current condition in accordance with AS2870-2011 'Residential Slabs and Footings', as shown in Table 4.
