Residential Subdivision
The Gardens - Stage 5
Site Classification

Nos. 688 to 730
Medowie Road,
Medowie

NEW19P-0143H-AA
14 February 2023

**RE: RESIDENTIAL SUBDIVISION – THE GARDENS – STAGE 5
Nos. 688 TO 730 MEDOWIE ROAD, MEDOWIE
SITE CLASSIFICATION (LOTS 501 TO 520)**

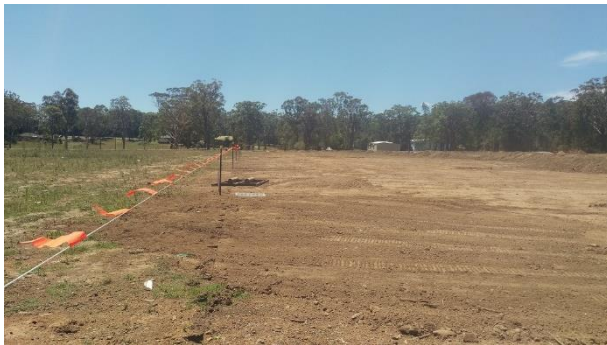
Photograph 1: From near south-western corner of Lot 501, facing north.

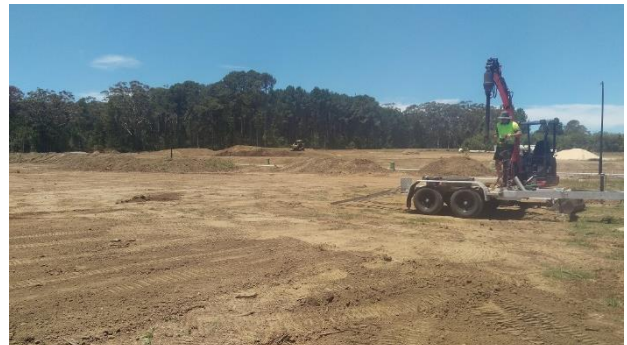
Photograph 2: From near south-western corner of Lot 501, facing northeast.

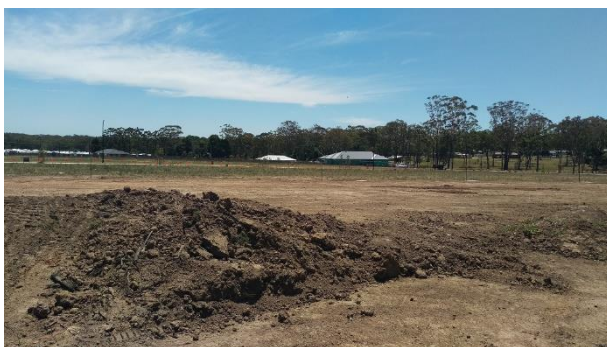
Photograph 3: From near eastern boundary of Lot 503, facing northwest.

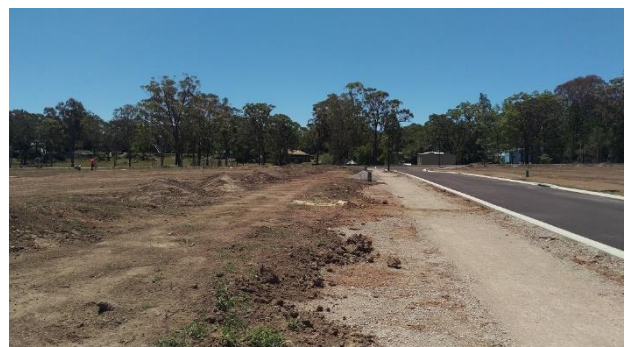
Photograph 4: From near eastern boundary of Lot 503, facing north.

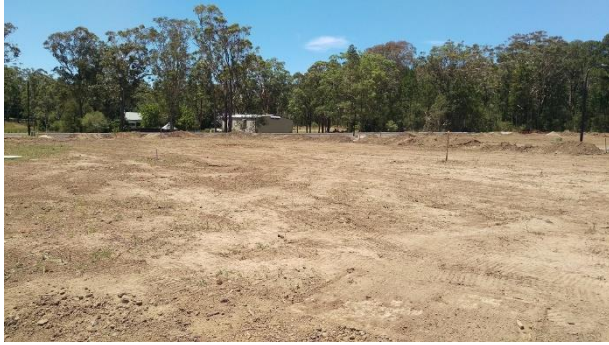
Photograph 5: From near south-western corner of Lot 507, facing north-northeast.

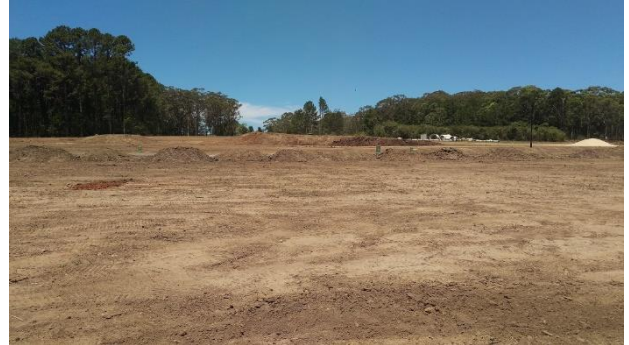
Photograph 6: From near south-western corner of Lot 507, facing east.

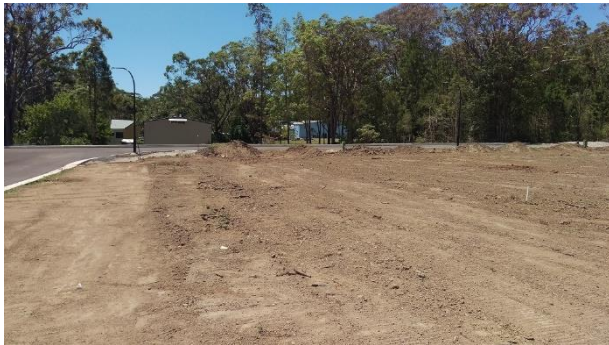
Photograph 7: From near south-western corner of Lot 510, facing north.

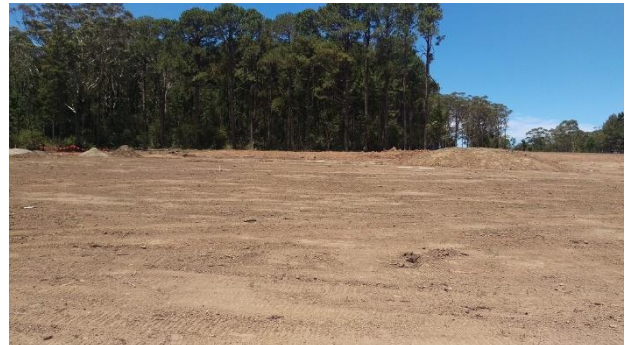
Photograph 8: From near south-western corner of Lot 510, facing east.

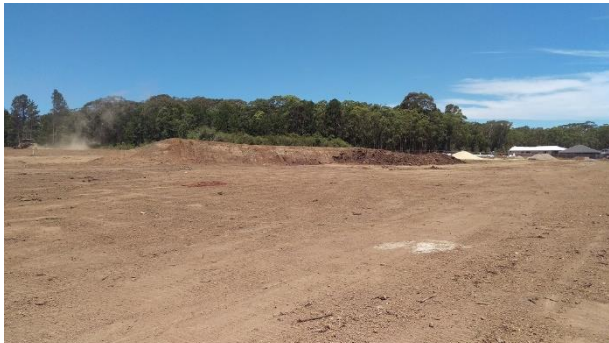
Photograph 9: From near south-western corner of Lot 510, facing southeast.

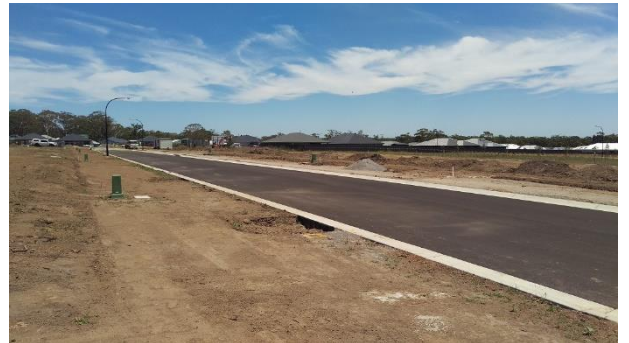
Photograph 10: From near south-western corner of Lot 510, facing south-southwest.

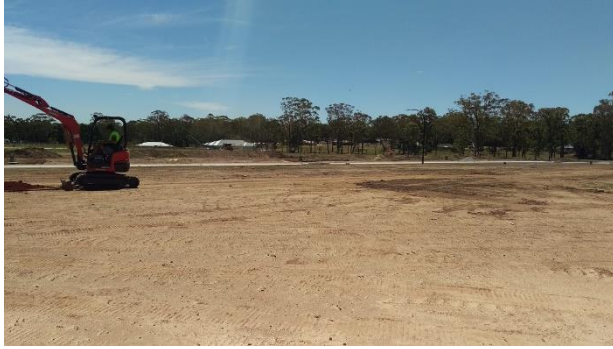
Photograph 11: From near south-eastern corner of Lot 520, facing northwest.

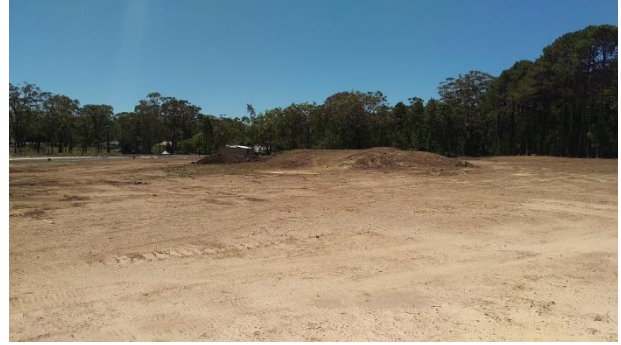
Photograph 12: From near south-eastern corner of Lot 520, facing northwest.

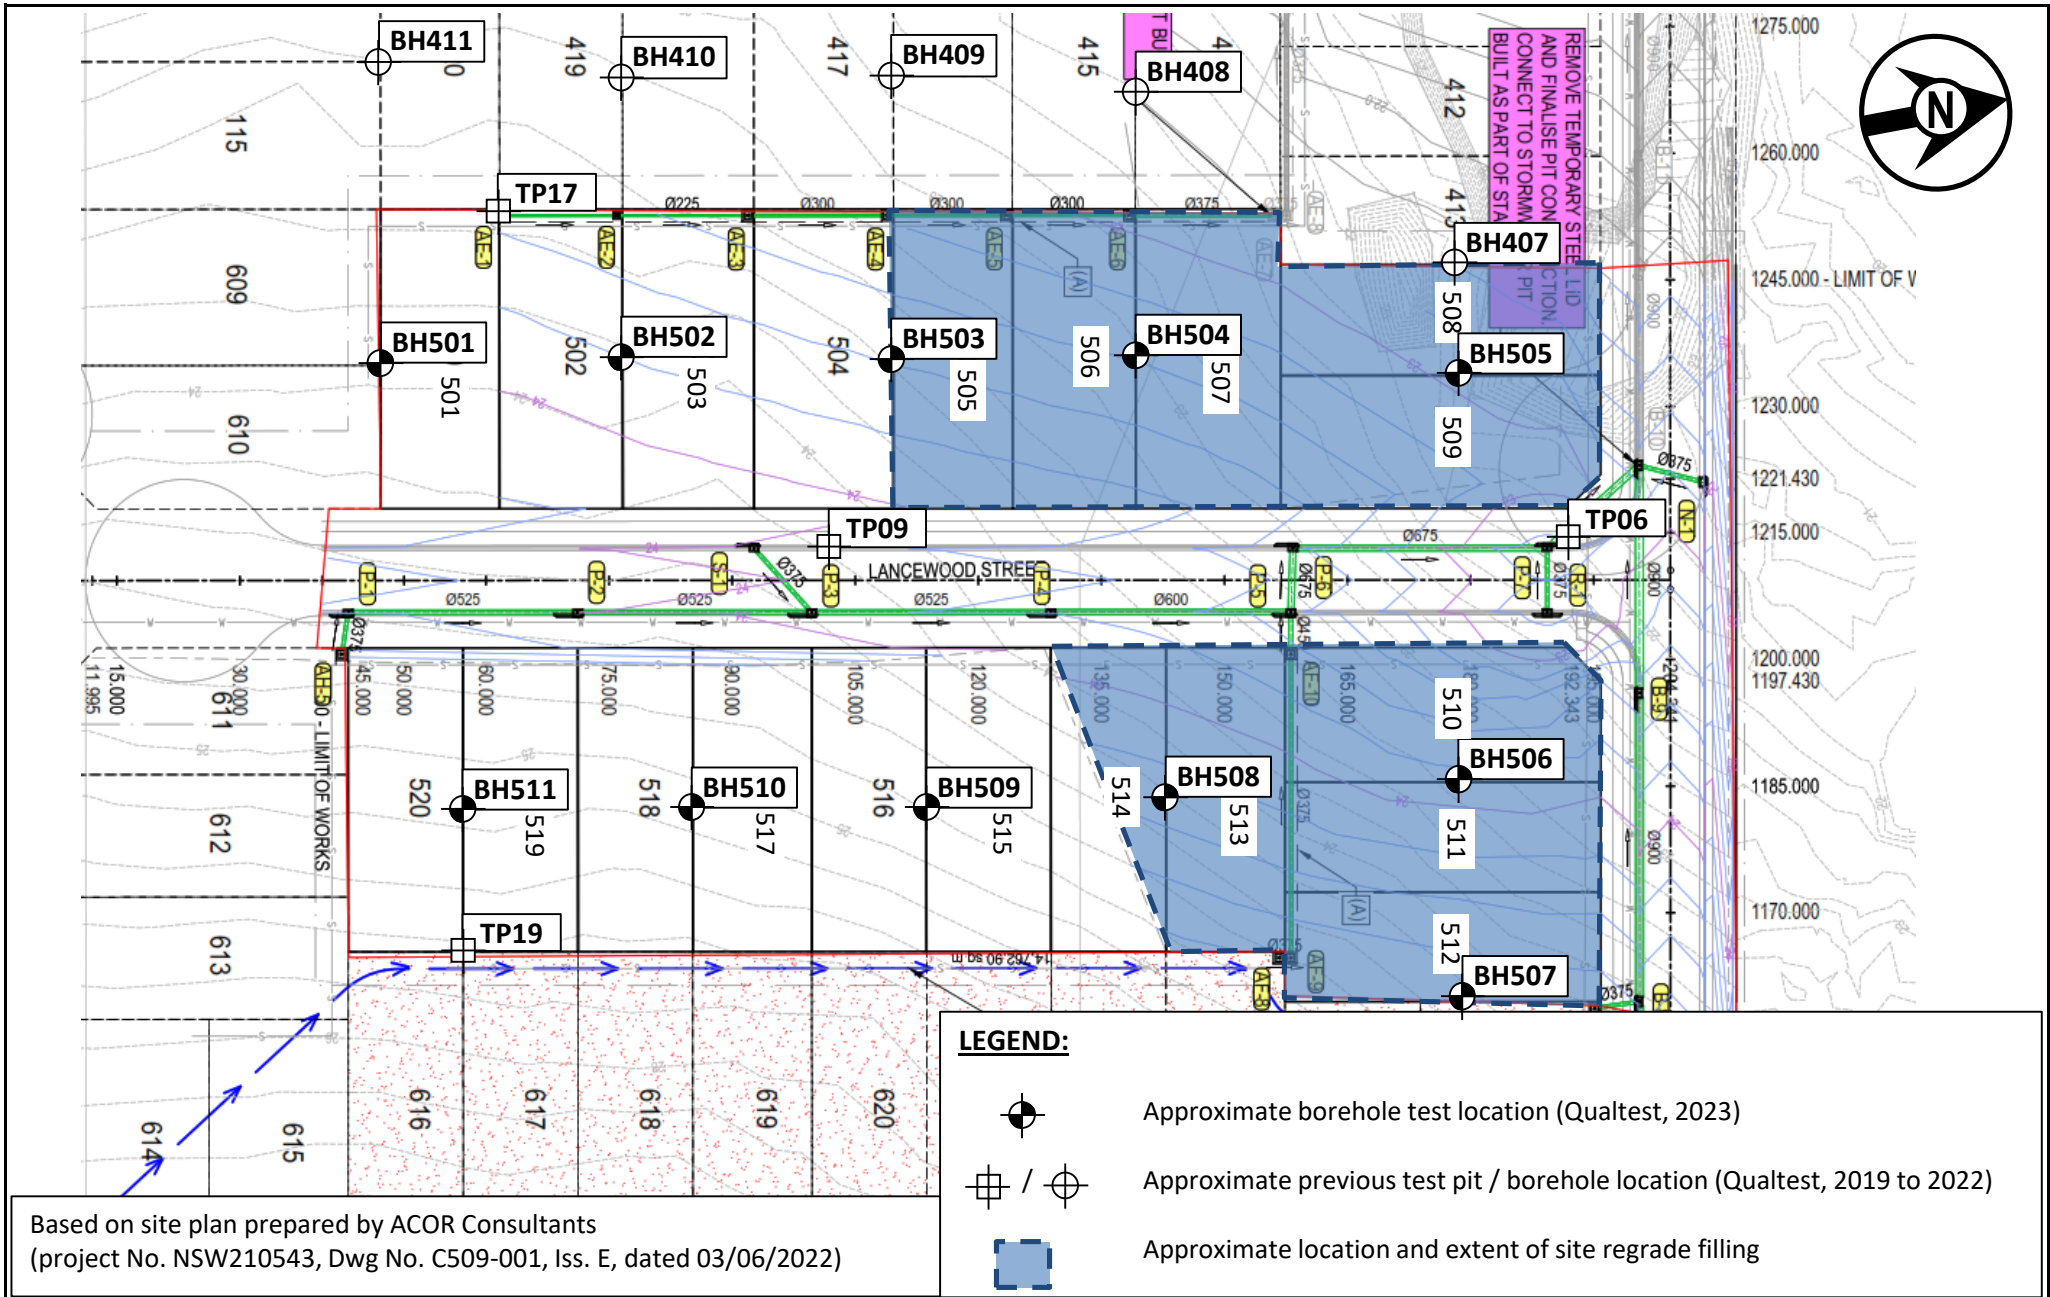
FIGURE AA1:

As the geotechnical testing authority engaged for the project, Qualtest state that the filling performed for the re-grade areas within Stage 5 (as noted above and shown approximately on Figure AA1) was carried out to Level 1 criteria as defined in Clause 8.2 – Section 8 of AS3798-2007, “Guidelines on Earthworks for Commercial and Residential Developments”.

Based on the results of the field work and laboratory testing, residential lots located within Stage 5 of The Gardens residential subdivision located at Nos. 688 to 730 Medowie Road, Medowie, as shown on Figure AA1, are classified in their current condition in accordance with AS2870-2011 'Residential Slabs and Footings', as shown in Table 4.
