Residential Subdivision
The Gardens - Stage 7
Site Classification

Medowie Road,
Medowie

NEW19P-0143B-AA
30 July 2021

**RE: RESIDENTIAL SUBDIVISION – THE GARDENS – STAGE 7
Nos. 688 TO 730 MEDOWIE ROAD, MEDOWIE
SITE CLASSIFICATION (LOTS 701 TO 721)**

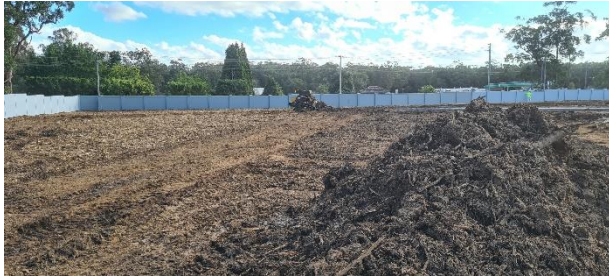
Photograph 1: From near BH723, facing west.

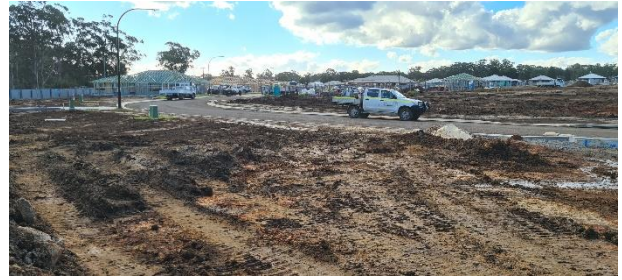
Photograph 2: From near BH723, facing northwest.

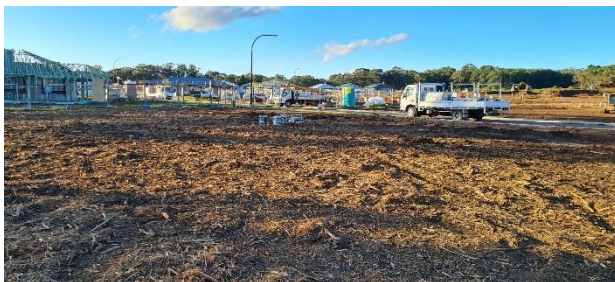
Photograph 3: From near BH703, facing northeast.

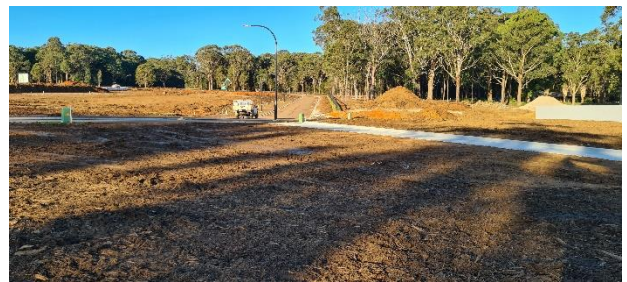
Photograph 4: From near BH703, facing east.

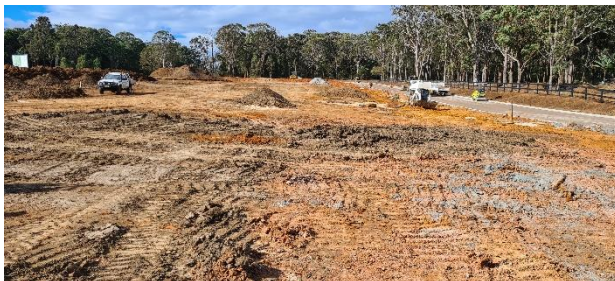
Photograph 5: From near BH707, facing east.

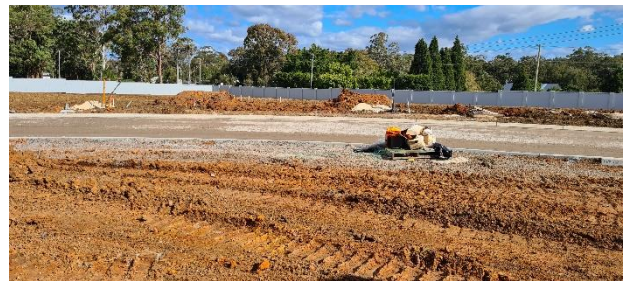
Photograph 6: From near BH707, facing southwest.

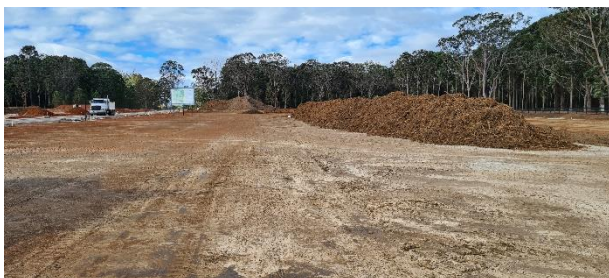
Photograph 7: From near BH717, facing east.

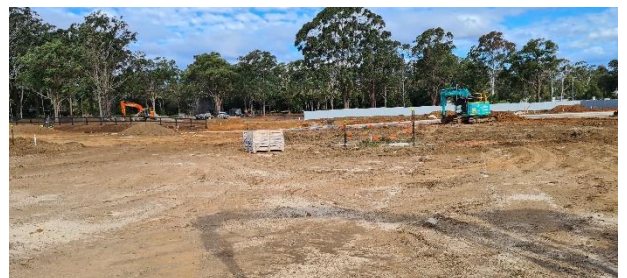
Photograph 8: From near BH717, facing south.

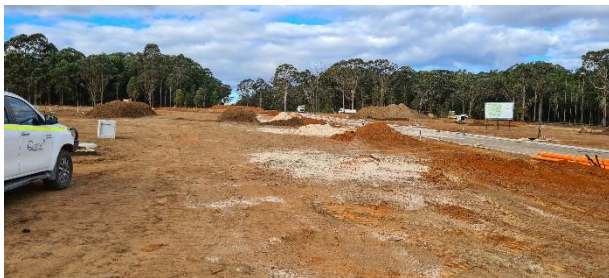
Photograph 9: From near BH722, facing southeast.

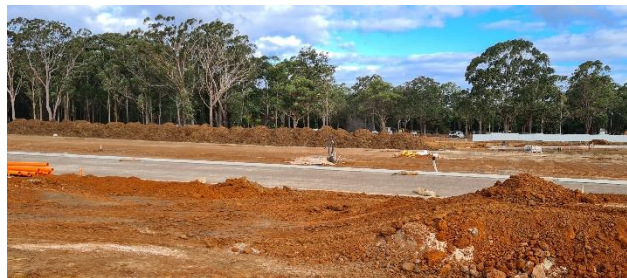
Photograph 10: From near BH722, facing south.

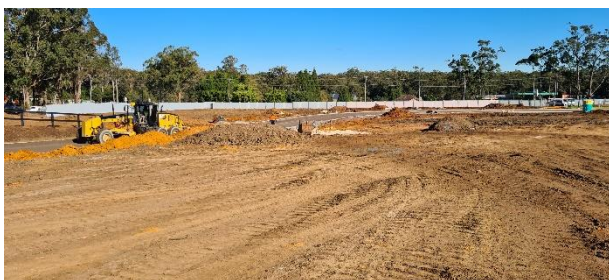
Photograph 11: From near BH712, facing west.

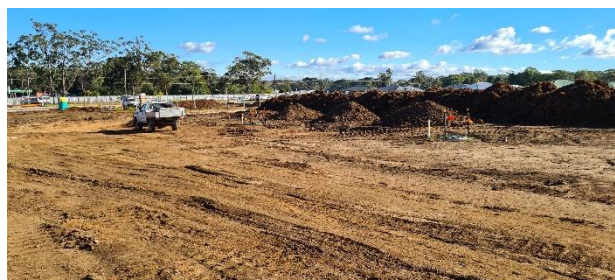
Photograph 12: From near BH712, facing northwest.

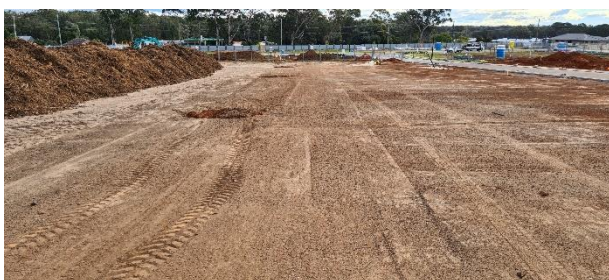
Photograph 13: From near BH713, facing northwest.

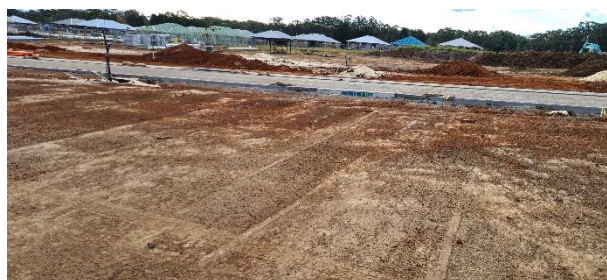
Photograph 14: From near BH713, facing north.
