Residential Subdivision  
The Gardens - Stage 6  
Site Classification

Nos. 688 to 730  
Medowie Road,  
Medowie

NEW19P-0143I-AA.Rev2  
8 March 2024

**RE: RESIDENTIAL SUBDIVISION – THE GARDENS – STAGE 6  
Nos. 688 TO 730 MEDOWIE ROAD, MEDOWIE  
SITE CLASSIFICATION (LOTS 601 TO 625)**

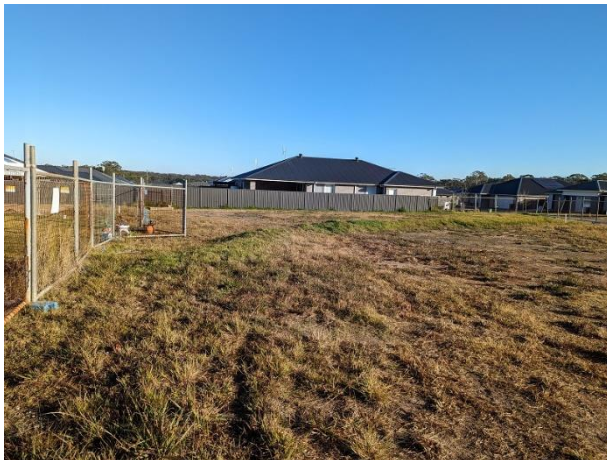
**Photograph 1:** From near southern boundary of Lot 603, facing west.

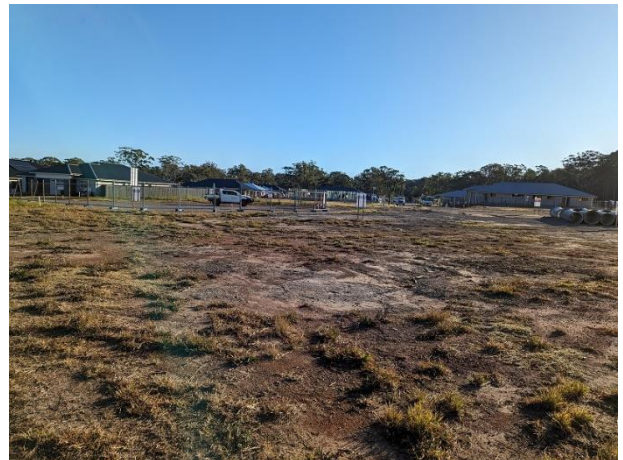
**Photograph 2:** From near southern boundary of Lot 603, facing north.

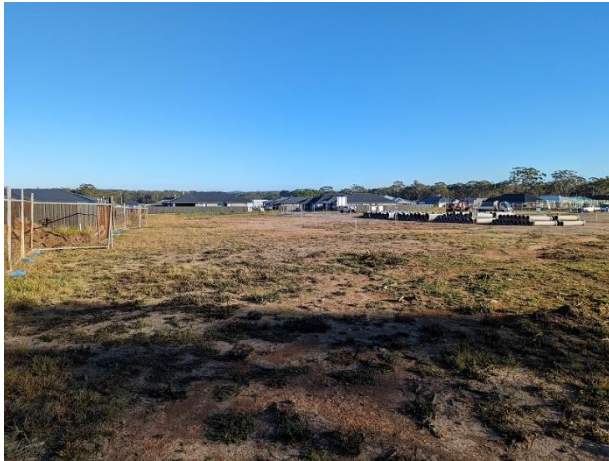
**Photograph 3:** From near south-eastern corner of Lot 607, facing west.

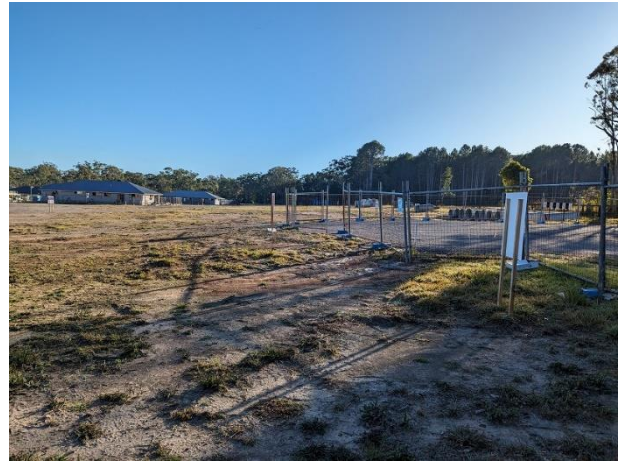
**Photograph 4:** From near south-eastern corner of Lot 607, facing north.

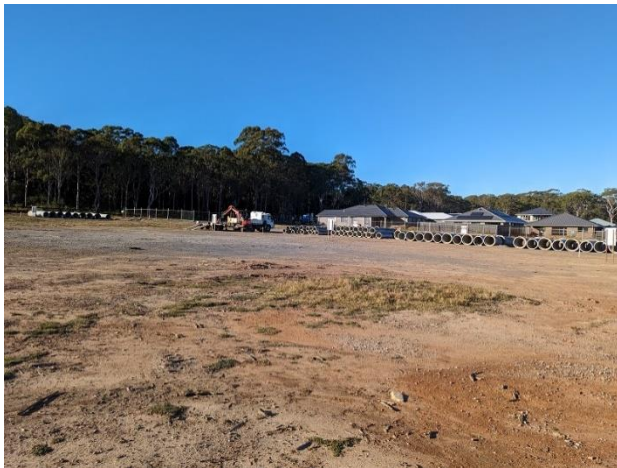
**Photograph 5:** From near eastern boundary of Lot 611, facing southeast.

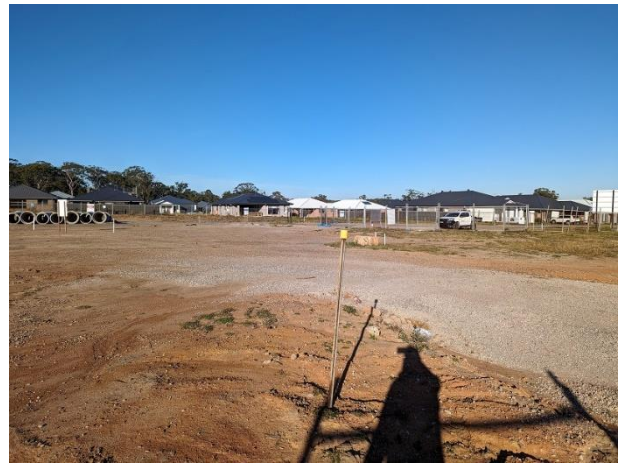
**Photograph 6:** From near eastern boundary of Lot 611, facing southwest.

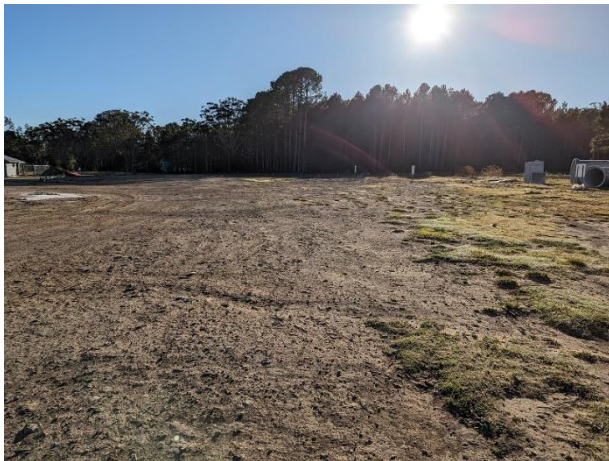
**Photograph 7:** From near shared boundary of Lots 613, 615, & 616, facing northeast.

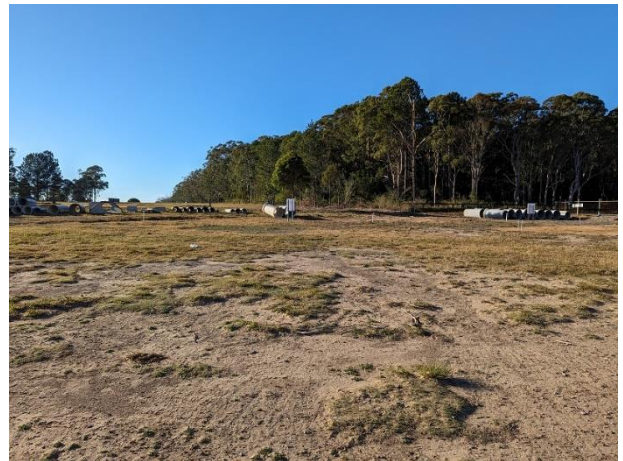
**Photograph 8:** From near shared boundary of Lots 613, 615, & 616, facing southeast.

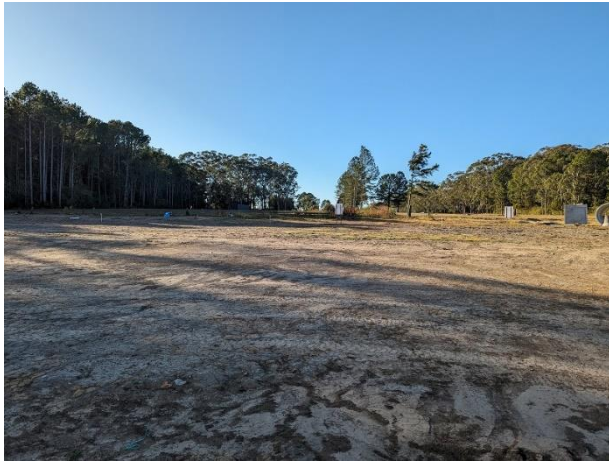
**Photograph 9:** From near western boundary of Lot 620, facing east.

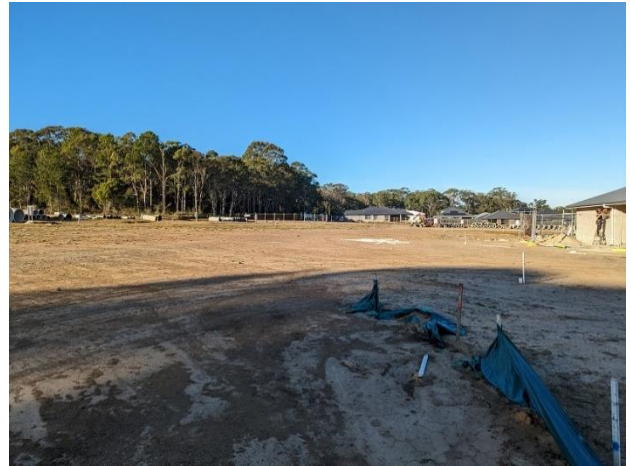
**Photograph 10:** From near western boundary of Lot 620, facing south.

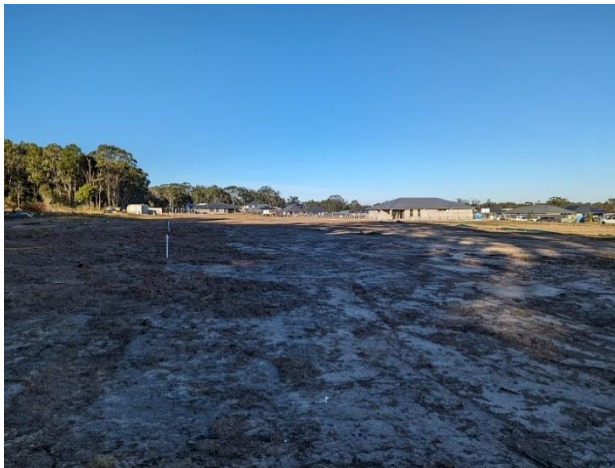
**Photograph 11:** From near eastern boundary of Lot 623, facing south.

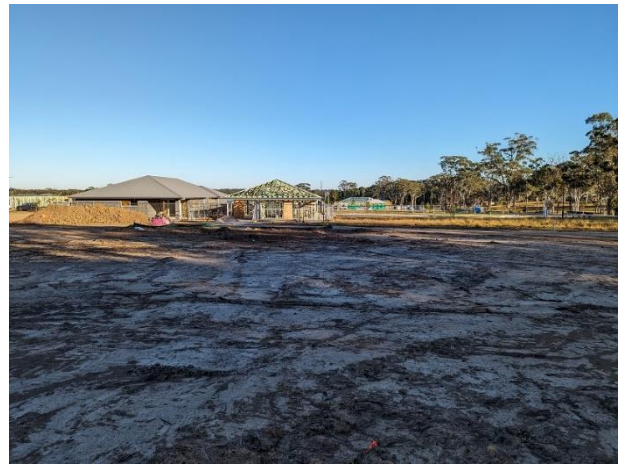
**Photograph 12:** From near eastern boundary of Lot 623, facing west.
